**Flood Control Project Maintenance
Levee Inspections**
LMA District Cover Sheet
Spring 2016 Levee Inspection Results

American River Flood Control District

Spring 2016 Levee Inspection Results

Waterway			Bank	Unit Miles
Unit No. 01 Arcade Creek			Left	2.08
	Spring (March - May)	Summer (June - August)	(September - November) Fall	Winter (December - February)
Unit Maintenance Rating (Fall Only)				
Date of Inspection	3/2/2016 - 3/2/2016			
DWR Inspector	Maksim Khashchuk			
Accompanied By	Richard Marck ARFCD			
	Sterling York

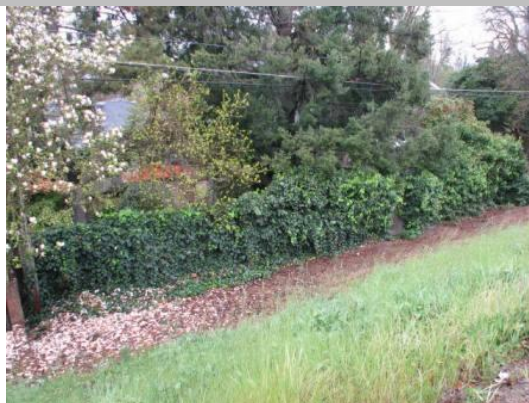
Photo 1 of 1 : SP_2016_NA0001_55_61_20160229_00049.jpg

LM Start	5.77	Rating **	U	Issue No.	61
LM End	5.77	Issue Type +	En	Location *	LS
Category	Earthen Levee			GPS Latitude/Longitude	
				Start	End
Item	Vegetation			38.572918 °	38.572918 °
				-121.423760 °	-121.423760 °
DWR ID	DWR_NA0001_04_s _ 2012_61				
Comment Code					
V6 : Landscaping					
Inspector Comment					
Dense ivy and shrubs are within 10-ft of the levee toe.

03/16/2012 Landscaping obstructs access and visibility.

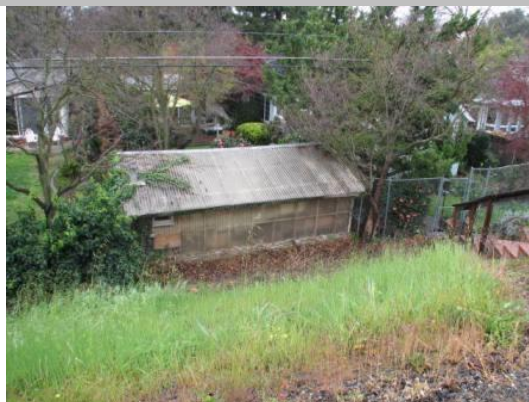
Photo 1 of 1 : SP_2016_NA0001_55_63_20160229_00050.jpg

LM Start	5.81	Rating **	U	Issue No.	63
LM End	5.81	Issue Type +	En	Location *	LS
Category	Earthen Levee			GPS Latitude/Longitude	
				Start	End
Item	Encroachments			38.572325 °	38.572325 °
				-121.423913 °	-121.423913 °
DWR ID	DWR_NA0001_04_s _ 2012_63				
Comment Code					
BU : Building					
Inspector Comment					
Wood and fiberglass structure within 10-ft of the levee toe.

03/16/2012 Wood and fiberglass structure is within 15' of levee toe.

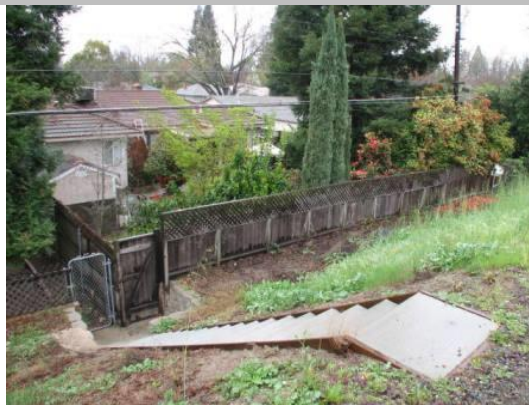
Photo 1 of 1 : SP_2016_NA0001_55_65_20160229_00051.jpg

LM Start	5.83	Rating **	U	Issue No.	65
LM End	5.83	Issue Type +	En	Location *	LS
Category	Earthen Levee			GPS Latitude/Longitude	
				Start	End
Item	Encroachments			38.572067 °	38.572067 °
				-121.423970 °	-121.423970 °
DWR ID	DWR_NA0001_04_s _ 2012_65				
Comment Code					
FE : Fence					
Inspector Comment					
Extended privacy fence and retaining wall within 10-ft of levee toe.

03/16/2012 Wood privacy fence completely obstructs access and visibility.

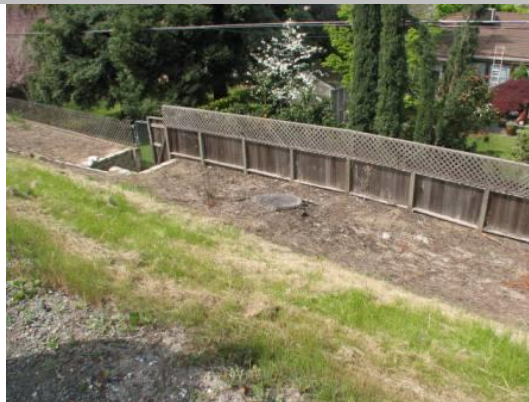
Photo 1 of 1 : SP_2016_NA0001_55_181_20160229_00158.jpg

LM Start	5.83	Rating **	N	Issue No.	181
LM End	5.83	Issue Type +	Ma	Location *	LS
Category	Earthen Levee			GPS Latitude/Longitude	
				Start	End
Item	Trim / Thin Trees			38.572032 °	38.572032 °
				-121.423981 °	-121.423981 °
DWR ID	DWR_NA0001_04_s _ 2012_181				
Comment Code					
T5 : Tree stumps.					
Inspector Comment					
04/14/2011 Large stump at toe of levee.

04/14/2011 Large stump at toe of levee.

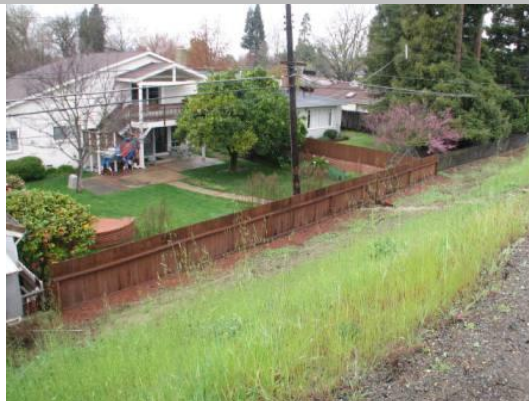
Photo 1 of 1 : SP_2016_NA0001_55_210_20160229_00175.jpg

LM Start	5.85	Rating **	U	Issue No.	210
LM End	5.85	Issue Type +	En	Location *	LS
Category	Earthen Levee			GPS Latitude/Longitude	
				Start	End
Item	Encroachments			38.571733 °	38.571733 °
				-121.424055 °	-121.424055 °
DWR ID	DWR_NA0001_04_s_2012_210				
Comment Code					
FE : Fence					
Inspector Comment					
Privacy fence and retaining wall are within 10-ft of levee toe.

03/16/2012 Wood privacy fence completely obstructs access and visibility.

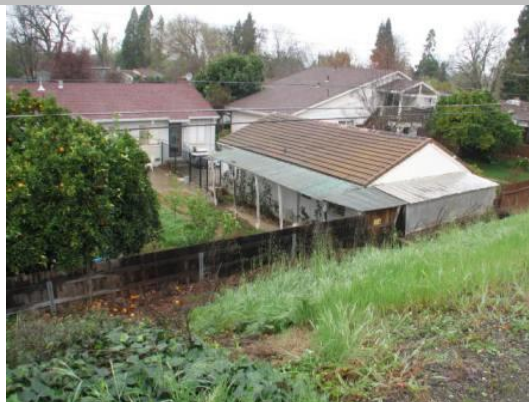
Photo 1 of 1 : SP_2016_NA0001_55_66_20160229_00052.jpg

LM Start	5.86	Rating **	U	Issue No.	66
LM End	5.86	Issue Type +	En	Location *	LS
Category	Earthen Levee			GPS Latitude/Longitude	
				Start	End
Item	Encroachments			38.571586 °	38.571586 °
				-121.424097 °	-121.424097 °
DWR ID	DWR_NA0001_04_s_2012_66				
Comment Code					
BU : Building					
Inspector Comment

03/16/2012 Structure is within 15' of levee toe.

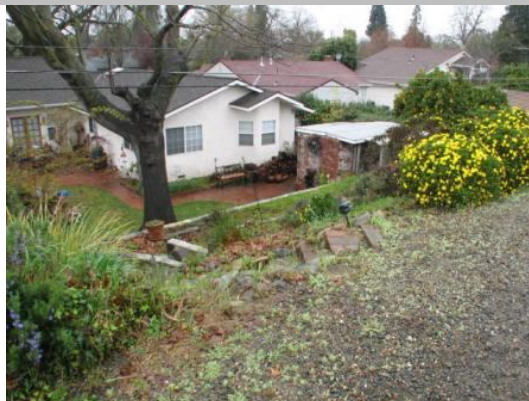
Photo 1 of 1 : SP_2016_NA0001_55_68_20160229_00054.jpg

LM Start	5.87	Rating **	U	Issue No.	68
LM End	5.87	Issue Type +	En	Location *	LS
Category	Earthen Levee			GPS Latitude/Longitude	
				Start	End
Item	Vegetation			38.571525 °	38.571525 °
				-121.424152 °	-121.424152 °
DWR ID	DWR_NA0001_04_f_2013_68				
Comment Code					
V6 : Landscaping					
Inspector Comment					
Levee slope has been landscaped. This obstructs visibility.

03/16/2012 Levee slope is heavily landscaped, retaining wall has been constructed at the levee toe.

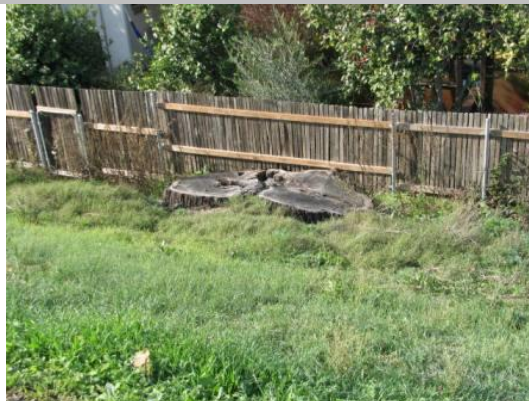
Photo 1 of 1 : SP_2016_NA0001_55_740_20160229_00192.jpg

LM Start	5.91	Rating **	N	Issue No.	740
LM End	5.91	Issue Type +	Ma	Location *	LS
Category	Earthen Levee			GPS Latitude/Longitude	
				Start	End
Item	Trim / Thin Trees			38.570940 °	38.570940 °
				-121.424173 °	-121.424173 °
DWR ID	DWR_NA0001_04_s_2012_740				
Comment Code					
T5 : Tree stumps.					
Inspector Comment					
Large stump

11/15/2011 Large stump at levee toe.

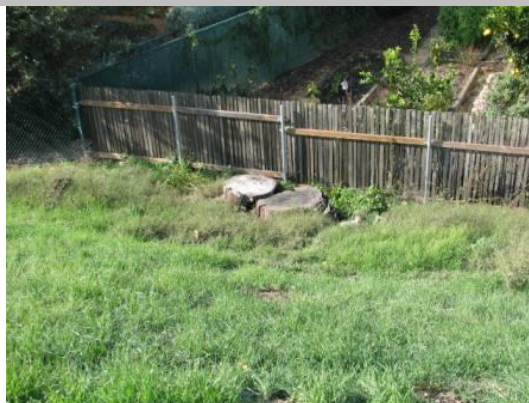
Photo 1 of 1 : SP_2016_NA0001_55_741_20160229_00193.jpg

LM Start	5.92	Rating **	N	Issue No.	741
LM End	5.92	Issue Type +	Ma	Location *	LS
Category	Earthen Levee			GPS Latitude/Longitude	
				Start	End
Item	Trim / Thin Trees			38.570800 °	38.570800 °
				-121.424184 °	-121.424184 °
DWR ID	DWR_NA0001_04_s_2012_741				
Comment Code					
T5 : Tree stumps.					
Inspector Comment					
Stump.

11/15/2011 Stump at levee toe.

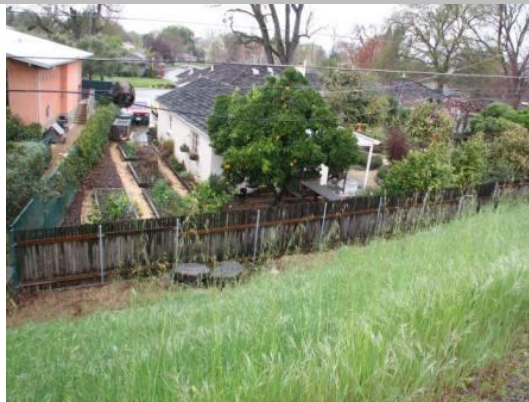
Photo 1 of 1 : SP_2016_NA0001_55_88_20160229_00072.jpg

LM Start	5.92	Rating **	U	Issue No.	88
LM End	5.92	Issue Type +	En	Location *	LS
Category	Earthen Levee			GPS Latitude/Longitude	
				Start	End
Item	Encroachments			38.570752 °	38.570752 °
				-121.424219 °	-121.424219 °
DWR ID	DWR_NA0001_04_f_2012_88				
Comment Code					
FE : Fence					
Inspector Comment					
Wooden privacy fence.

03/16/2012 Wood privacy fence completely obstructs access and visibility.

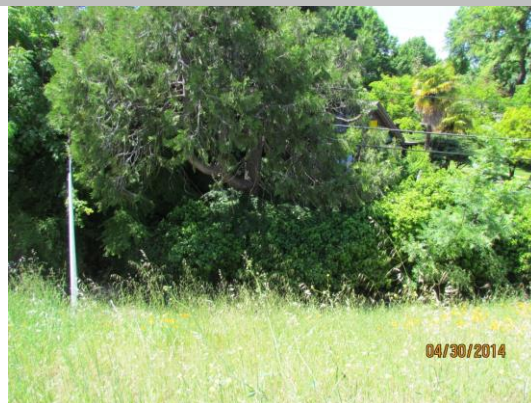
Photo 1 of 1 : SP_2016_NA0001_55_71_20160229_00055.jpg

LM Start	5.94	Rating **	M	Issue No.	71
LM End	5.94	Issue Type +	En	Location *	LS
Category	Earthen Levee			GPS Latitude/Longitude	
				Start	End
Item	Vegetation			38.570450 °	38.570450 °
				-121.424237 °	-121.424237 °
DWR ID	DWR_NA0001_04_s_2012_71				
Comment Code					
V6 : Landscaping					
Inspector Comment					
Landscaping and garden within 10-ft of the levee toe.

View of the landscaping at the landside levee toe.

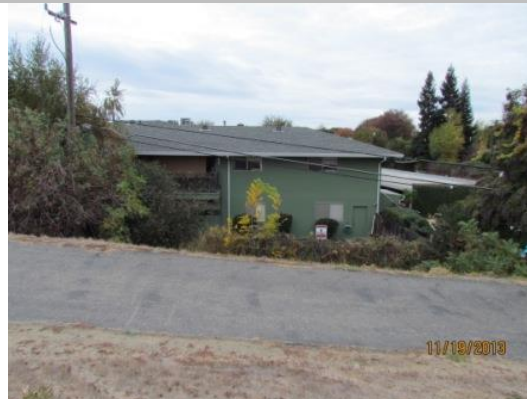
Photo 1 of 1 : SP_2016_NA0001_55_211_20160229_00176.jpg

LM Start	5.98	Rating **	M	Issue No.	211
LM End	5.98	Issue Type +	En	Location *	LS
Category	Earthen Levee			GPS Latitude/Longitude	
				Start	End
Item	Encroachments			38.569893 °	38.569893 °
				-121.424310 °	-121.424310 °
DWR ID	DWR_NA0001_04_s_2012_211				
Comment Code					
FE : Fence					
Inspector Comment					
Apartment complex privacy fence and shrubs within 10-ft of the slope obstruct visibility.

View of the fence at the landside levee toe.

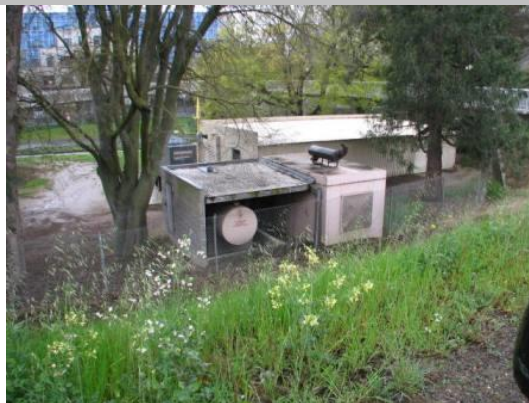
Photo 1 of 1 : SP_2016_NA0001_55_73_20160229_00057.jpg

LM Start	6.58	Rating **	U	Issue No.	73
LM End	6.58	Issue Type +	En	Location *	LS
Category	Earthen Levee			GPS Latitude/Longitude	
				Start	End
Item	Encroachments			38.561643 °	38.561643 °
				-121.421262 °	-121.421262 °
DWR ID	DWR_NA0001_04_s_2012_73				
Comment Code					
BU : Building					
Inspector Comment					
Generator and sheds within 10-ft of levee slope.

03/16/2012 Structure for generator is within 5' of levee toe.

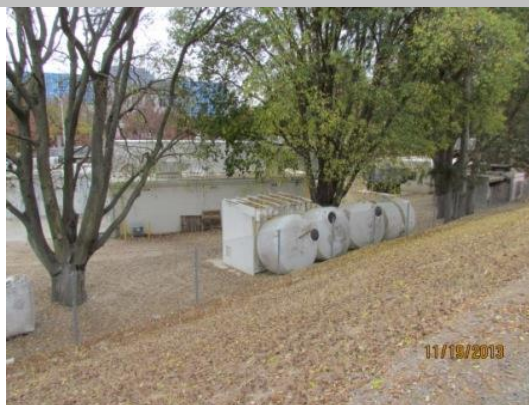
Photo 1 of 1 : SP_2016_NA0001_55_185_20160229_00159.jpg

LM Start	6.60	Rating **	M	Issue No.	185
LM End	6.60	Issue Type +	En	Location *	LS
Category	Earthen Levee			GPS Latitude/Longitude	
				Start	End
Item	Encroachments			38.561448 °	38.561448 °
				-121.421071 °	-121.421071 °
DWR ID	DWR_NA0001_04_f_2013_185				
Comment Code					
TA : Tank					
Inspector Comment					
5 water tanks and storage shed within 10 feet of landside levee toe.

View of the water tanks stored at the landside levee toe.

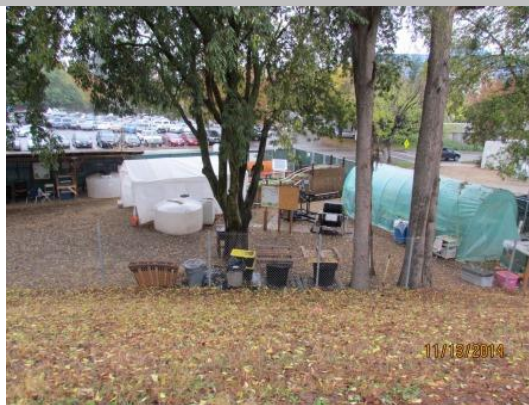
Photo 1 of 1 : SP_2016_NA0001_55_51_20160229_00041.jpg

LM Start	6.62	Rating **	M	Issue No.	51
LM End	6.62	Issue Type +	En	Location *	LS
Category	Earthen Levee			GPS Latitude/Longitude	
				Start	End
Item	Encroachments			38.561117 °	38.561117 °
				-121.420749 °	-121.420749 °
DWR ID	DWR_NA0001_04_f_2013_51				
Comment Code					
MA : Material					
Inspector Comment					
Pipe and other material stored within 10 feet of landside levee toe.

View of the material stored at the landside levee toe.

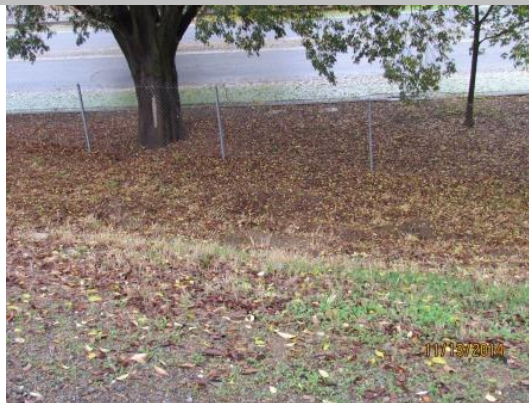
Photo 1 of 1 : SP_2016_NA0001_55_240_20160229_00186.jpg

LM Start	6.65	Rating **	M	Issue No.	240
LM End	6.65	Issue Type +	Ma	Location *	LS
Category	Earthen Levee			GPS Latitude/Longitude	
				Start	End
Item	Animal Control			38.560883 °	38.560883 °
				-121.420514 °	-121.420514 °
DWR ID	DWR_NA0001_04_f_2014_240				
Comment Code					
A1 : Exterminate rodents and backfill and compact or grout burrows.					
Inspector Comment

View of a rodent burrow at the landside levee toe.

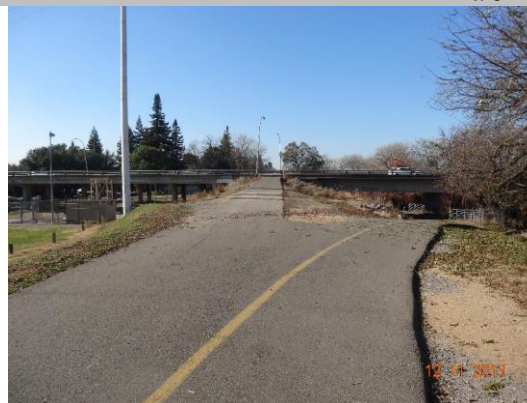
Photo 1 of 2 : UCIP_SP_2016_30023_55394.jpg

Comment Code					
Inspector Comment					
FS_ID:30023 DS_ID:24319 EP_NO: 3596 Repair Type: Non-Urgent Crossing Status: Indicator Found UCIP Comments: Need to contact owners to determine how crossing was abandoned. FIELD_STRUCT_DESC: *ABANDONED* [Power Inn Road Plant] 4 of 4: 48-inch corrugated metal (CM) drainpipe through the levee, 20.0 feet below the crown. Two CM cutoff walls around pipe under each shoulder. Slide gate with control pedestal in CM pipe riser on waterside (WS) slope. Slide gate with control pedestal in collection sump on landside (LS). Pumping plant at LS toe. Reinforced concrete discharge box at the toe of the WS slope. Flap gate on WS end. (Permit No. 3596-1962) 60-inch discharge pipe from box across the berm to the riverbank installed under Permit No. 5894 (1970). Pipe abandoned and CM pipe riser cut 2.0 feet below ground surface under Permit No. 3596A (1998). FS Date: 12/11/2013

Overview of levee crown at crossings.

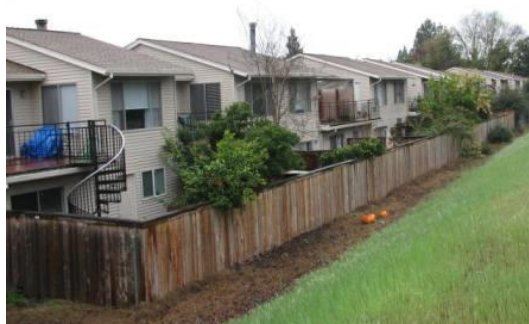
Photo 1 of 1 : SP_2016_NA0001_55_75_20160229_00059.jpg

LM Start	7.69	Rating **	U	Issue No.	75
LM End	7.72	Issue Type +	En	Location *	LS
Category	Earthen Levee			GPS Latitude/Longitude	
				Start	End
Item	Encroachments			38.559230 °	38.559261 °
				-121.402708 °	-121.402219 °
DWR ID	DWR_NA0001_04_s _ 2012_75				
Comment Code					
FE : Fence					
Inspector Comment					
Wooden privacy fence for seven apartment units is within 10-ft of levee toe and obstructs access and visibility.

03/16/2012 Wood privacy fence completely obstructs access and visibility.

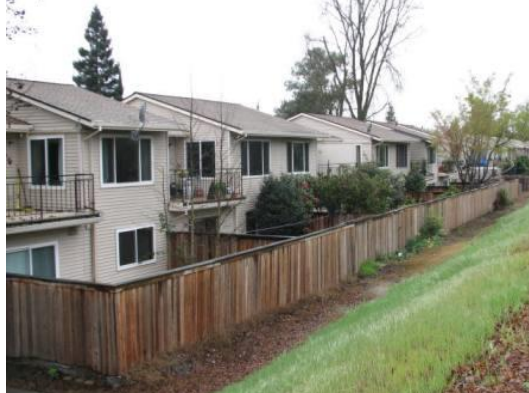
Photo 1 of 1 : SP_2016_NA0001_55_76_20160229_00060.jpg

LM Start	7.75	Rating **	U	Issue No.	76
LM End	7.76	Issue Type +	En	Location *	LS
Category	Earthen Levee			GPS Latitude/Longitude	
				Start	End
Item	Encroachments			38.559308 °	38.559309 °
				-121.401717 °	-121.401388 °
DWR ID	DWR_NA0001_04_s _ 2012_76				
Comment Code					
FE : Fence					
Inspector Comment					
Wooden privacy fence for seven apartment units is within 10-ft of levee toe and obstructs access and visibility.

03/16/2012 Wood privacy fence completely obstructs access and visibility.

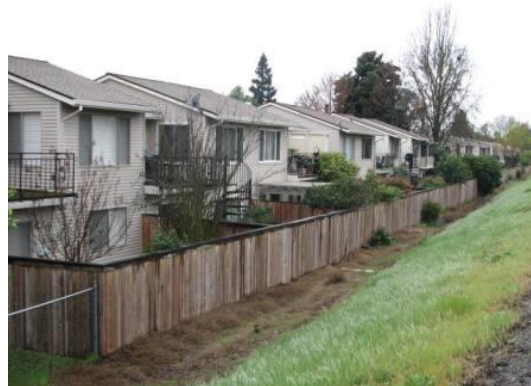
Photo 1 of 1 : SP_2016_NA0001_55_77_20160229_00061.jpg

LM Start	7.78	Rating **	U	Issue No.	77
LM End	7.80	Issue Type +	En	Location *	LS
Category	Earthen Levee			GPS Latitude/Longitude	
				Start	End
Item	Encroachments			38.559330 °	38.559366 °
				-121.401162 °	-121.400683 °
DWR ID	DWR_NA0001_04_s_2012_77				
Comment Code					
FE : Fence					
Inspector Comment					
Wooden privacy fence for seven apartment units is within 10-ft of levee toe and obstructs access and visibility.

03/16/2012 Wood privacy fence completely obstructs access and visibility.

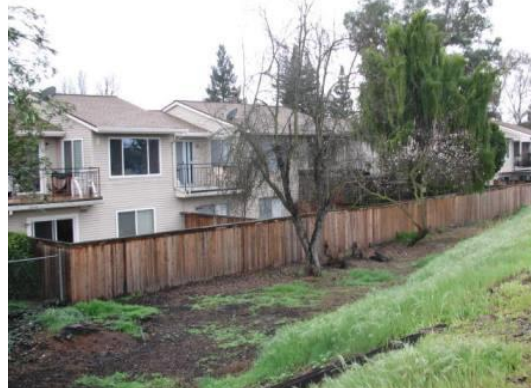
Photo 1 of 1 : SP_2016_NA0001_55_78_20160229_00062.jpg

LM Start	7.82	Rating **	U	Issue No.	78
LM End	7.84	Issue Type +	En	Location *	LS
Category	Earthen Levee			GPS Latitude/Longitude	
				Start	End
Item	Encroachments			38.559379 °	38.559435 °
				-121.400354 °	-121.399944 °
DWR ID	DWR_NA0001_04_s_2012_78				
Comment Code					
FE : Fence					
Inspector Comment					
Wooden privacy fence for seven apartment units is within 10-ft of levee toe and obstructs access and visibility.

03/16/2012 Wood privacy fence completely obstructs access and visibility.

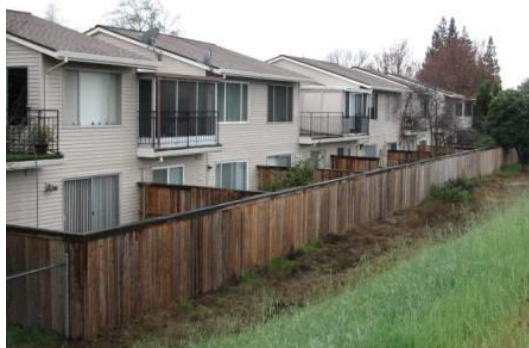
Photo 1 of 1 : SP_2016_NA0001_55_79_20160229_00063.jpg

LM Start	7.86	Rating **	U	Issue No.	79
LM End	7.88	Issue Type +	En	Location *	LS
Category	Earthen Levee			GPS Latitude/Longitude	
				Start	End
Item	Encroachments			38.559514 °	38.559643 °
				-121.399700 °	-121.399248 °
DWR ID	DWR_NA0001_04_s _ 2012_79				
Comment Code					
FE : Fence					
Inspector Comment					
Wooden privacy fence for seven apartment units is within 10-ft of levee toe and obstructs access and visibility.

03/16/2012 Wood privacy fence completely obstructs access and visibility.

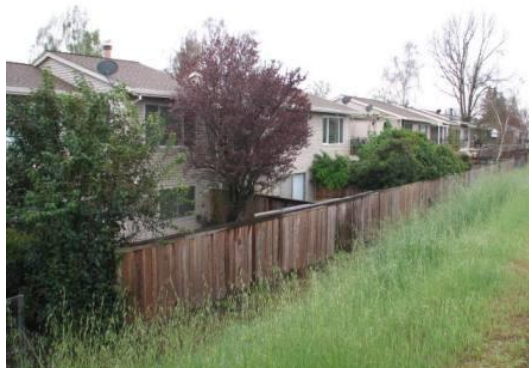
Photo 1 of 1 : SP_2016_NA0001_55_80_20160229_00064.jpg

LM Start	7.90	Rating **	U	Issue No.	80
LM End	7.93	Issue Type +	En	Location *	LS
Category	Earthen Levee			GPS Latitude/Longitude	
				Start	End
Item	Encroachments			38.559753 °	38.559911 °
				-121.398982 °	-121.398506 °
DWR ID	DWR_NA0001_04_s _ 2012_80				
Comment Code					
FE : Fence					
Inspector Comment					
Wooden privacy fence for seven apartment units is within 10-ft of levee toe and obstructs access and visibility.

03/16/2012 Wood privacy fence completely obstructs access and visibility.

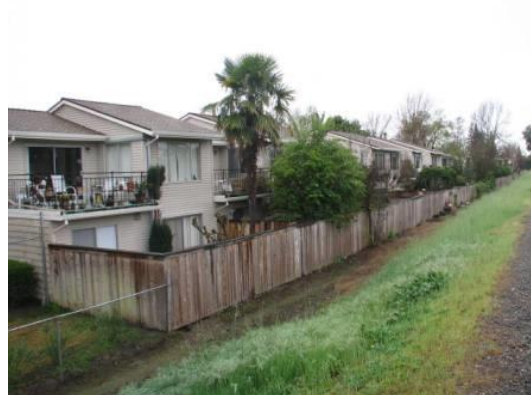
Photo 1 of 1 : SP_2016_NA0001_55_224_20160229_00177.jpg

LM Start	7.94	Rating **	U	Issue No.	224
LM End	7.97	Issue Type +	En	Location *	LS
Category	Earthen Levee			GPS Latitude/Longitude	
				Start	End
Item	Encroachments			38.559994 °	38.560185 °
				-121.398318 °	-121.397845 °
DWR ID	DWR_NA0001_04_s_2012_224				
Comment Code					
FE : Fence					
Inspector Comment					
Wooden privacy fence for seven apartment units is within 10-ft of levee toe and obstructs access and visibility.

03/16/2012 Wood privacy fence completely obstructs access and visibility.

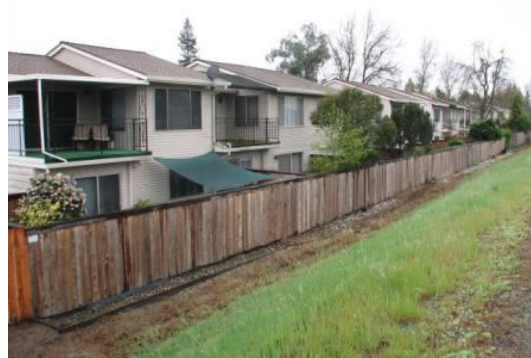
Photo 1 of 1 : SP_2016_NA0001_55_81_20160229_00065.jpg

LM Start	7.98	Rating **	U	Issue No.	81
LM End	8.00	Issue Type +	En	Location *	LS
Category	Earthen Levee			GPS Latitude/Longitude	
				Start	End
Item	Encroachments			38.560281 °	38.560435 °
				-121.397604 °	-121.397239 °
DWR ID	DWR_NA0001_04_s _ 2012_81				
Comment Code					
FE : Fence					
Inspector Comment					
Wooden privacy fence for seven apartment units is within 10-ft of levee toe and obstructs access and visibility.

03/16/2012 Wood privacy fence completely obstructs access and visibility.

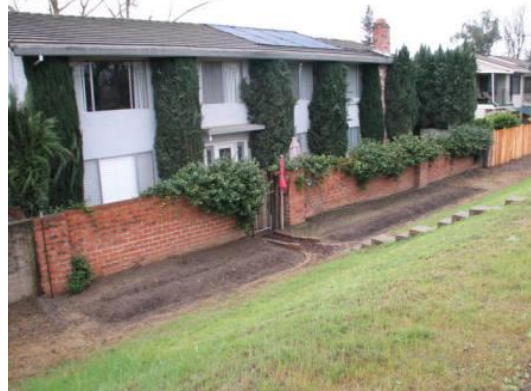
Photo 1 of 1 : SP_2016_NA0001_55_82_20160229_00066.jpg

LM Start	8.02	Rating **	U	Issue No.	82
LM End	8.02	Issue Type +	En	Location *	LS
Category	Earthen Levee			GPS Latitude/Longitude	
				Start	End
Item	Encroachments			38.560537 °	38.560537 °
				-121.396912 °	-121.396912 °
DWR ID	DWR_NA0001_04_s _ 2012_82				
Comment Code					
FE : Fence					
Inspector Comment					
Brick fence is within 10-ft of levee toe, obstructing access and visibility.

03/16/2012 Brick wall completely obstructs access and visibility.

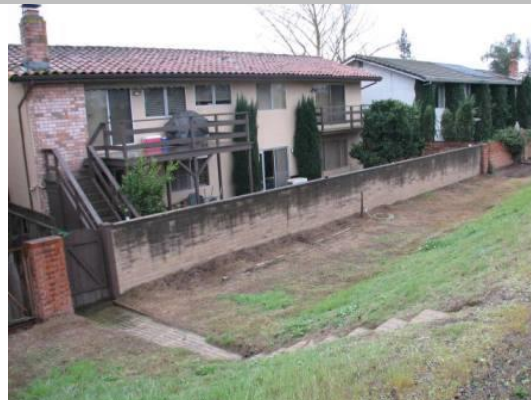
Photo 1 of 1 : SP_2016_NA0001_55_83_20160229_00067.jpg

LM Start	8.04	Rating **	U	Issue No.	83
LM End	8.04	Issue Type +	En	Location *	LS
Category	Earthen Levee			GPS Latitude/Longitude	
				Start	End
Item	Encroachments			38.560647 °	38.560647 °
				-121.396660 °	-121.396660 °
DWR ID	DWR_NA0001_04_s _ 2012_83				
Comment Code					
FE : Fence					
Inspector Comment					
Brick fence is within 10-ft of levee toe and obstructs access and visibility.

03/16/2012 Brick wall completely obstructs access and visibility.

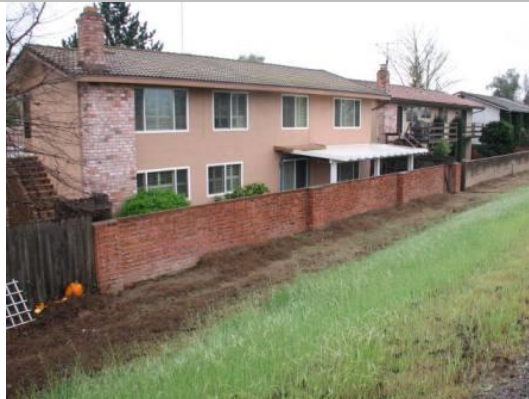
Photo 1 of 1 : SP_2016_NA0001_55_84_20160229_00068.jpg

LM Start	8.05	Rating **	U	Issue No.	84
LM End	8.05	Issue Type +	En	Location *	LS
Category	Earthen Levee			GPS Latitude/Longitude	
				Start	End
Item	Encroachments			38.560728 °	38.560728 °
				-121.396471 °	-121.396471 °
DWR ID	DWR_NA0001_04_s_2012_84				
Comment Code					
FE : Fence					
Inspector Comment					
Brick fence is within 10-ft of levee toe and obstructs access and visibility.

03/16/2012 Brick wall completely obstructs access and visibility.

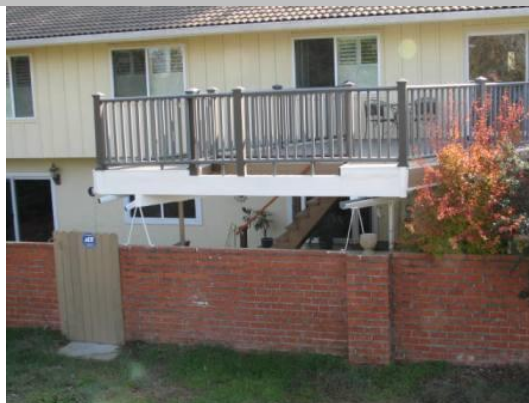
Photo 1 of 1 : SP_2016_NA0001_55_745_20160229_00194.jpg

LM Start	8.06	Rating **	A/W	Issue No.	745
LM End	8.06	Issue Type +	En	Location *	LS
Category	Earthen Levee			GPS Latitude/Longitude	
				Start	End
Item	Encroachments			38.560830 °	38.560830 °
				-121.396232 °	-121.396232 °
DWR ID	DWR_NA0001_04_s_2012_745				
Comment Code					
UR : Urban					
Inspector Comment					
Drains direct gutter flow onto levee toe.

11/15/2011 Gutter drains that are suspended from the balcony direct flow onto the levee toe.

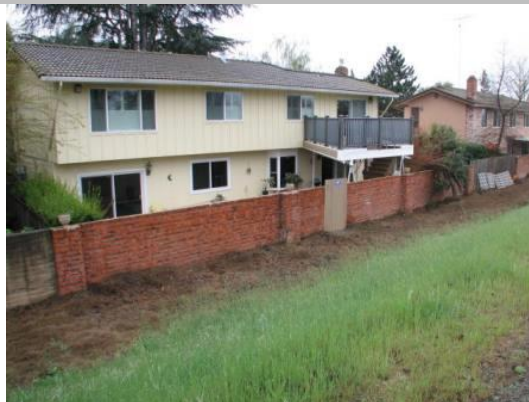
Photo 1 of 1 : SP_2016_NA0001_55_85_20160229_00069.jpg

LM Start	8.07	Rating **	U	Issue No.	85
LM End	8.07	Issue Type +	En	Location *	LS
Category	Earthen Levee			GPS Latitude/Longitude	
				Start	End
Item	Encroachments			38.560845 °	38.560845 °
				-121.396189 °	-121.396189 °
DWR ID	DWR_NA0001_04_s_2012_85				
Comment Code					
FE : Fence					
Inspector Comment					
Brick fence is within 10-ft of levee toe and obstructs access and visibility.

03/16/2012 Brick wall completely obstructs access and visibility.

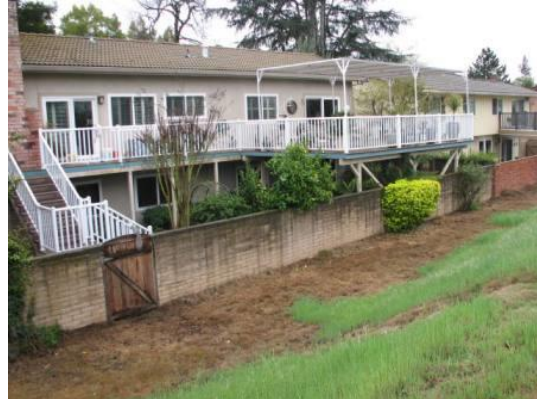
Photo 1 of 1 : SP_2016_NA0001_55_86_20160229_00070.jpg

LM Start	8.08	Rating **	U	Issue No.	86
LM End	8.08	Issue Type +	En	Location *	LS
Category	Earthen Levee			GPS Latitude/Longitude	
				Start	End
Item	Encroachments			38.560907 °	38.560907 °
				-121.396043 °	-121.396043 °
DWR ID	DWR_NA0001_04_s_2012_86				
Comment Code					
FE : Fence					
Inspector Comment					
Brick fence is within 10-ft of levee toe and obstructs access and visibility.

03/16/2012 Brick wall completely obstructs access and visibility.

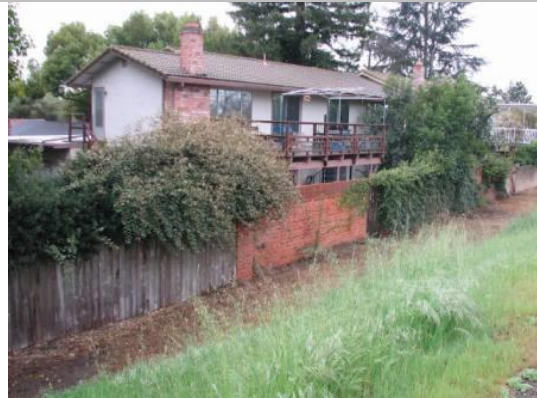
Photo 1 of 1 : SP_2016_NA0001_55_87_20160229_00071.jpg

LM Start	8.09	Rating **	U	Issue No.	87
LM End	8.09	Issue Type +	En	Location *	LS
Category	Earthen Levee			GPS Latitude/Longitude	
				Start	End
Item	Encroachments			38.561008 °	38.561008 °
				-121.395817 °	-121.395817 °
DWR ID	DWR_NA0001_04_s_2012_87				
Comment Code					
FE : Fence					
Inspector Comment					
Brick fence is within 10-ft of levee toe and obstructs access and visibility.

03/16/2012 Brick wall completely obstructs access and visibility.

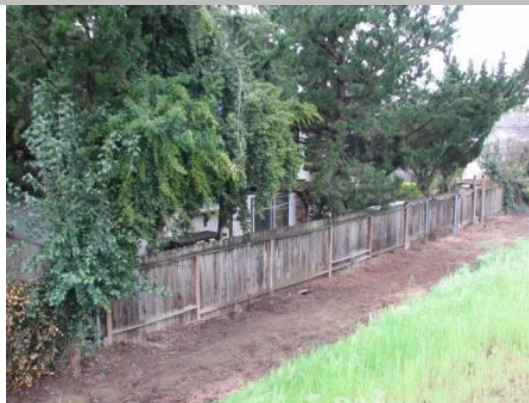
Photo 1 of 1 : SP_2016_NA0001_55_89_20160229_00073.jpg

LM Start	8.16	Rating **	U	Issue No.	89
LM End	8.16	Issue Type +	En	Location *	LS
Category	Earthen Levee			GPS Latitude/Longitude	
				Start	End
Item	Encroachments			38.561467 °	38.561467 °
				-121.394728 °	-121.394728 °
DWR ID	DWR_NA0001_04_s_2012_89				
Comment Code					
FE : Fence					
Inspector Comment					
Fence and landscaping arbor within 10-ft of levee toe obstructs access and visibility.

03/16/2012 Wood privacy fence completely obstructs access and visibility.

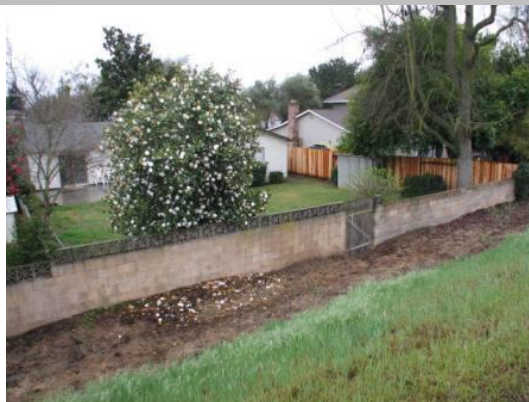
Photo 1 of 1 : SP_2016_NA0001_55_90_20160229_00074.jpg

LM Start	8.17	Rating **	U	Issue No.	90
LM End	8.17	Issue Type +	En	Location *	LS
Category	Earthen Levee			GPS Latitude/Longitude	
				Start	End
Item	Encroachments			38.561544 °	38.561544 °
				-121.394494 °	-121.394494 °
DWR ID	DWR_NA0001_04_s_2012_90				
Comment Code					
FE : Fence					
Inspector Comment					
Cement block fence within 10-ft of the levee toe.

03/16/2012 Cinder block wall completely obstructs access and visibility.

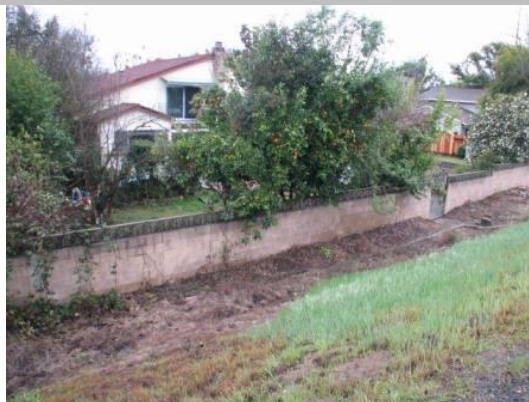
Photo 1 of 1 : SP_2016_NA0001_55_91_20160229_00075.jpg

LM Start	8.18	Rating **	U	Issue No.	91
LM End	8.18	Issue Type +	En	Location *	LS
Category	Earthen Levee			GPS Latitude/Longitude	
				Start	End
Item	Encroachments			38.561593 °	38.561593 °
				-121.394315 °	-121.394315 °
DWR ID	DWR_NA0001_04_s_2012_91				
Comment Code					
FE : Fence					
Inspector Comment					
Concrete block fence and landscaping within 10-ft of levee toe obstructs access and visibility.

03/16/2012 Cinder block wall completely obstructs access and visibility.

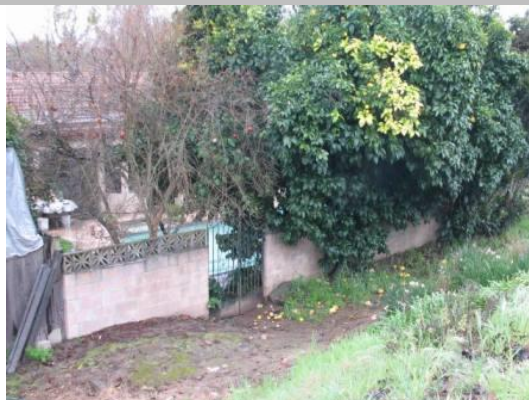
Photo 1 of 1 : SP_2016_NA0001_55_92_20160229_00076.jpg

LM Start	8.19	Rating **	U	Issue No.	92
LM End	8.19	Issue Type +	En	Location *	LS
Category	Earthen Levee			GPS Latitude/Longitude	
				Start	End
Item	Encroachments			38.561658 °	38.561658 °
				-121.394157 °	-121.394157 °
DWR ID	DWR_NA0001_04_s _ 2012_92				
Comment Code					
FE : Fence					
Inspector Comment					
Cement block fence and landscaping within 10-ft of levee toe obstructs access and visibility.

03/16/2012 Cinder block fence completely obstructs access and visibility.

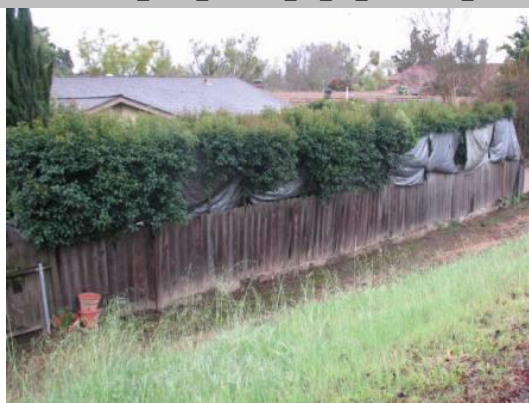
Photo 1 of 1 : SP_2016_NA0001_55_93_20160229_00077.jpg

LM Start	8.21	Rating **	U	Issue No.	93
LM End	8.21	Issue Type +	En	Location *	LS
Category	Earthen Levee			GPS Latitude/Longitude	
				Start	End
Item	Encroachments			38.561750 °	38.561750 °
				-121.393917 °	-121.393917 °
DWR ID	DWR_NA0001_04_s _ 2012_93				
Comment Code					
FE : Fence					
Inspector Comment					
Wooden fence, strung tarps, and landscaping within 10-ft of levee toe obstructs access and visibility.

03/16/2012 Wood privacy fence completely obstructs access and visibility.

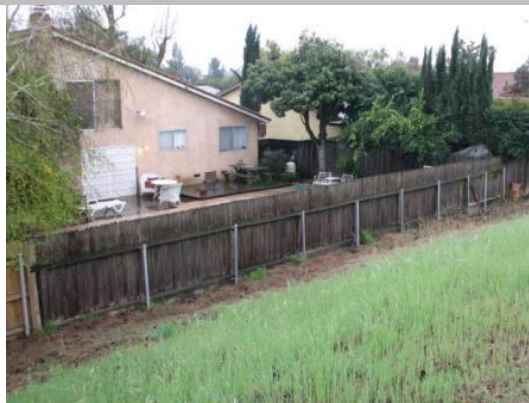
Photo 1 of 1 : SP_2016_NA0001_55_94_20160229_00078.jpg

LM Start	8.21	Rating **	U	Issue No.	94
LM End	8.21	Issue Type +	En	Location *	LS
Category	Earthen Levee			GPS Latitude/Longitude	
				Start	End
Item	Encroachments			38.561799 °	38.561799 °
				-121.393758 °	-121.393758 °
DWR ID	DWR_NA0001_04_s _ 2012_94				
Comment Code					
FE : Fence					
Inspector Comment					
Wood privacy fence and pool within 10-ft of levee toe obstructs access and visibility.

03/16/2012 Wood privacy fence completely obstructs access and visibility.

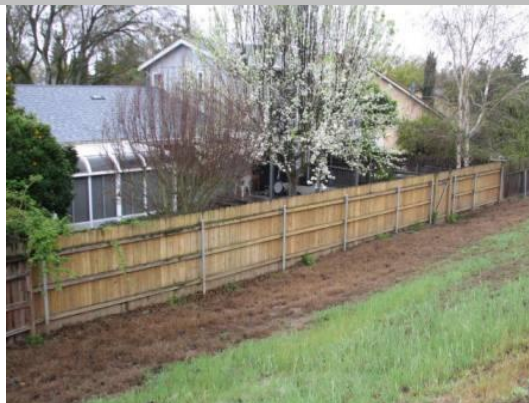
Photo 1 of 1 : SP_2016_NA0001_55_95_20160229_00079.jpg

LM Start	8.23	Rating **	U	Issue No.	95
LM End	8.23	Issue Type +	En	Location *	LS
Category	Earthen Levee			GPS Latitude/Longitude	
				Start	End
Item	Encroachments			38.561900 °	38.561900 °
				-121.393547 °	-121.393547 °
DWR ID	DWR_NA0001_04_s _ 2012_95				
Comment Code					
FE : Fence					
Inspector Comment					
Wood privacy fence within 10-ft of levee toe obstructs access and visibility.

03/16/2012 Wood privacy fence completely obstructs access and visibility.

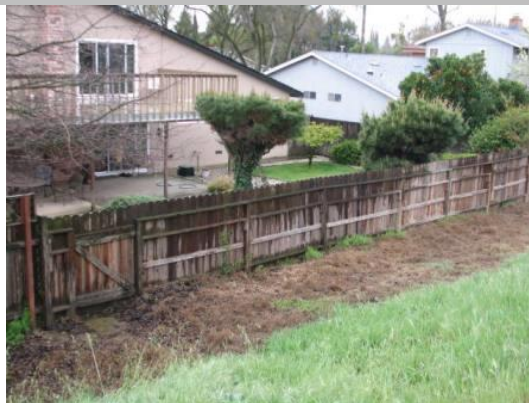
Photo 1 of 1 : SP_2016_NA0001_55_97_20160229_00081.jpg

LM Start	8.24	Rating **	U	Issue No.	97
LM End	8.24	Issue Type +	En	Location *	LS
Category	Earthen Levee			GPS Latitude/Longitude	
				Start	End
Item	Encroachments			38.561986 °	38.561986 °
				-121.393343 °	-121.393343 °
DWR ID	DWR_NA0001_04_s _ 2012_97				
Comment Code					
FE : Fence					
Inspector Comment					
Wood privacy fence within 10-ft of levee toe obstructs access and visibility.

03/16/2012 Wood privacy fence completely obstructs access and visibility.

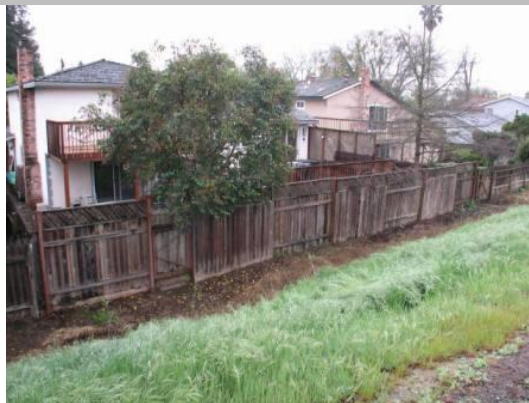
Photo 1 of 1 : SP_2016_NA0001_55_98_20160229_00082.jpg

LM Start	8.25	Rating **	U	Issue No.	98
LM End	8.25	Issue Type +	En	Location *	LS
Category	Earthen Levee			GPS Latitude/Longitude	
				Start	End
Item	Encroachments			38.562054 °	38.562054 °
				-121.393190 °	-121.393190 °
DWR ID	DWR_NA0001_04_s _ 2012_98				
Comment Code					
FE : Fence					
Inspector Comment					
Wood privacy fence within 10-ft of levee toe obstructs access and visibility.

03/16/2012 Wood privacy fence completely obstructs access and visibility.

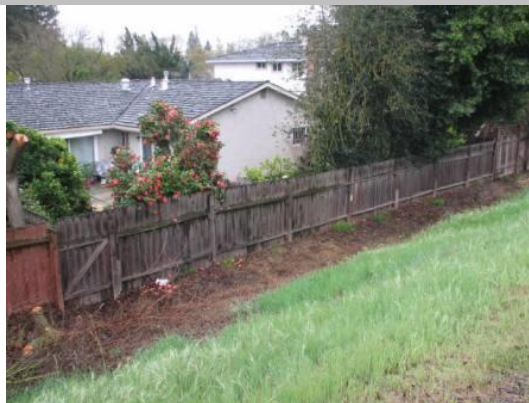
Photo 1 of 1 : SP_2016_NA0001_55_99_20160229_00083.jpg

LM Start	8.26	Rating **	U	Issue No.	99
LM End	8.26	Issue Type +	En	Location *	LS
Category	Earthen Levee			GPS Latitude/Longitude	
				Start	End
Item	Encroachments			38.562120 °	38.562120 °
				-121.392983 °	-121.392983 °
DWR ID	DWR_NA0001_04_s_2012_99				
Comment Code					
FE : Fence					
Inspector Comment					
Wood privacy fence within 10-ft of levee toe obstructs access and visibility.

03/16/2012 Wood privacy fence completely obstructs access and visibility.

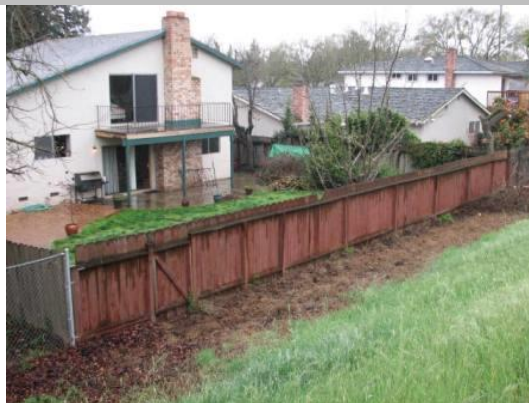
Photo 1 of 1 : SP_2016_NA0001_55_100_20160229_00084.jpg

LM Start	8.27	Rating **	U	Issue No.	100
LM End	8.27	Issue Type +	En	Location *	LS
Category	Earthen Levee			GPS Latitude/Longitude	
				Start	End
Item	Encroachments			38.562182 °	38.562182 °
				-121.392778 °	-121.392778 °
DWR ID	DWR_NA0001_04_s_2012_100				
Comment Code					
FE : Fence					
Inspector Comment					
Wood privacy fence within 10-ft of levee toe obstructs access and visibility.

03/16/2012 Wood privacy fence completely obstructs access and visibility.

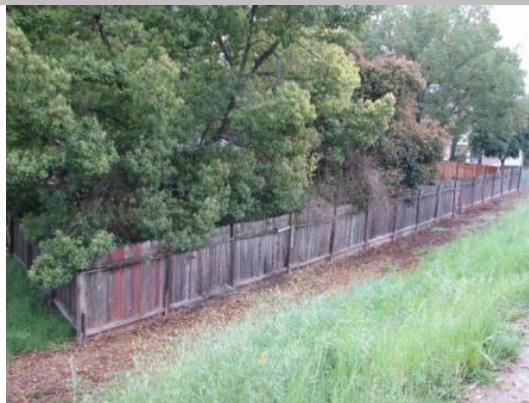
Photo 1 of 1 : SP_2016_NA0001_55_101_20160229_00085.jpg

LM Start	8.32	Rating **	U	Issue No.	101
LM End	8.32	Issue Type +	En	Location *	LS
Category	Earthen Levee			GPS Latitude/Longitude	
				Start	End
Item	Encroachments			38.562508 °	38.562508 °
				-121.392037 °	-121.392037 °
DWR ID	DWR_NA0001_04_s_2012_101				
Comment Code					
FE : Fence					
Inspector Comment					
Wood privacy fence within 10-ft of levee toe obstructs access and visibility.

03/16/2012 Wood privacy fence completely obstructs access and visibility.

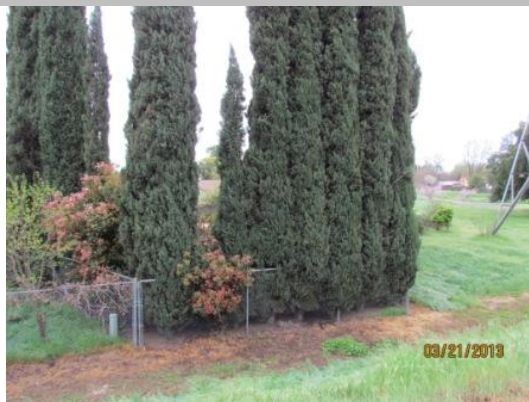
Photo 1 of 1 : SP_2016_NA0001_55_102_20160229_00086.jpg

LM Start	8.38	Rating **	M	Issue No.	102
LM End	8.38	Issue Type +	En	Location *	LS
Category	Earthen Levee			GPS Latitude/Longitude	
				Start	End
Item	Vegetation			38.562889 °	38.562889 °
				-121.391042 °	-121.391042 °
DWR ID	DWR_NA0001_04_s_2012_102				
Comment Code					
V6 : Landscaping					
Inspector Comment					
Helix sky pencil along chain link fence is within 10-ft of the levee toe.

View of the landscaping at the levee toe.

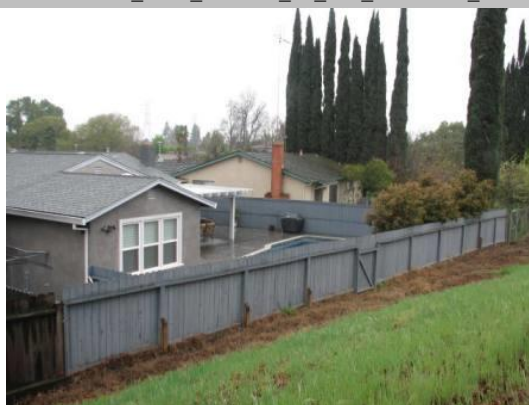
Photo 1 of 1 : SP_2016_NA0001_55_103_20160229_00087.jpg

LM Start	8.40	Rating **	U	Issue No.	103
LM End	8.40	Issue Type +	En	Location *	LS
Category	Earthen Levee			GPS Latitude/Longitude	
				Start	End
Item	Encroachments			38.563042 °	38.563042 °
				-121.390692 °	-121.390692 °
DWR ID	DWR_NA0001_04_s_2012_103				
Comment Code					
FE : Fence					
Inspector Comment					
Wood privacy fence within 10-ft of levee toe obstructs access and visibility.

03/16/2012 Wood privacy fence completely obstructs access and visibility.

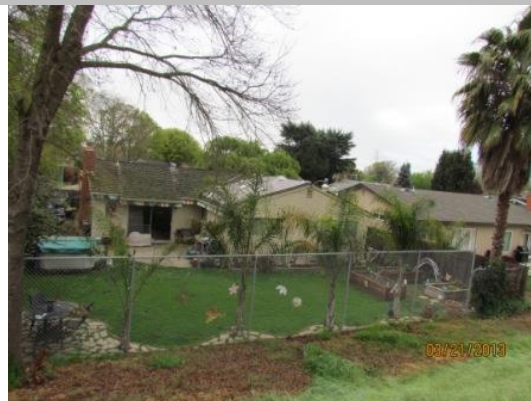
Photo 1 of 1 : SP_2016_NA0001_55_105_20160229_00089.jpg

LM Start	8.44	Rating **	M	Issue No.	105
LM End	8.44	Issue Type +	En	Location *	LS
Category	Earthen Levee			GPS Latitude/Longitude	
				Start	End
Item	Vegetation			38.563238 °	38.563238 °
				-121.390073 °	-121.390073 °
DWR ID	DWR_NA0001_04_s _ 2012_105				
Comment Code					
V6 : Landscaping					
Inspector Comment					
Palms planted within 10-ft of the levee toe.

View of the palm trees at the levee toe.

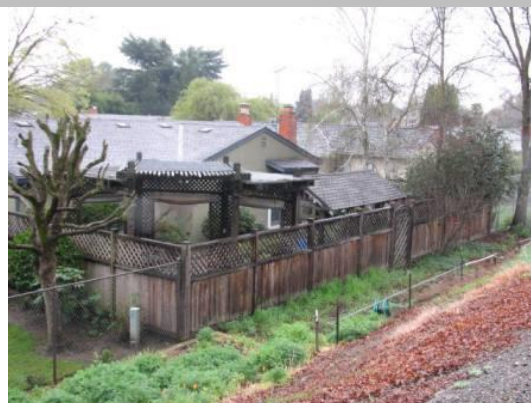
Photo 1 of 1 : SP_2016_NA0001_55_106_20160229_00090.jpg

LM Start	8.45	Rating **	U	Issue No.	106
LM End	8.45	Issue Type +	En	Location *	LS
Category	Earthen Levee			GPS Latitude/Longitude	
				Start	End
Item	Encroachments			38.563308 °	38.563308 °
				-121.389885 °	-121.389885 °
DWR ID	DWR_NA0001_04_s _ 2012_106				
Comment Code					
FE : Fence					
Inspector Comment					
Wood privacy fence within 10-ft of levee toe obstructs access and visibility. Block wall built into the levee.

03/16/2012 Wood privacy fence completely obstructs access and visibility.

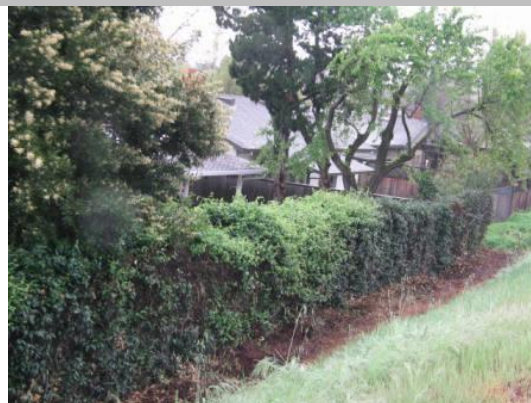
Photo 1 of 1 : SP_2016_NA0001_55_107_20160229_00091.jpg

LM Start	8.47	Rating **	U	Issue No.	107
LM End	8.47	Issue Type +	En	Location *	LS
Category	Earthen Levee			GPS Latitude/Longitude	
				Start	End
Item	Vegetation			38.563511 °	38.563511 °
				-121.389509 °	-121.389509 °
DWR ID	DWR_NA0001_04_s_2012_107				
Comment Code					
V6 : Landscaping					
Inspector Comment

03/16/2012 Landscaping obstructs visibility and access.

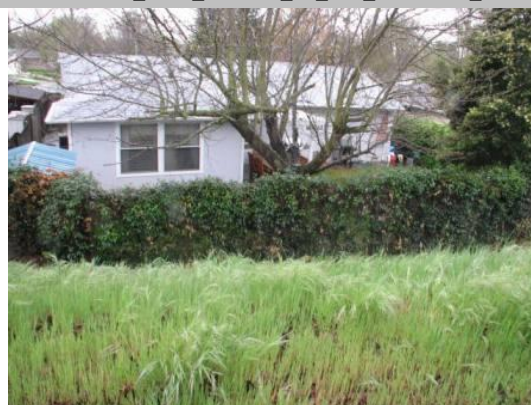
Photo 1 of 1 : SP_2016_NA0001_55_108_20160229_00092.jpg

LM Start	8.48	Rating **	U	Issue No.	108
LM End	8.48	Issue Type +	En	Location *	LS
Category	Earthen Levee			GPS Latitude/Longitude	
				Start	End
Item	Vegetation			38.563587 °	38.563587 °
				-121.389313 °	-121.389313 °
DWR ID	DWR_NA0001_04_s_2012_108				
Comment Code					
V6 : Landscaping					
Inspector Comment

03/16/2012 Landscaping obstructs visibility and access.

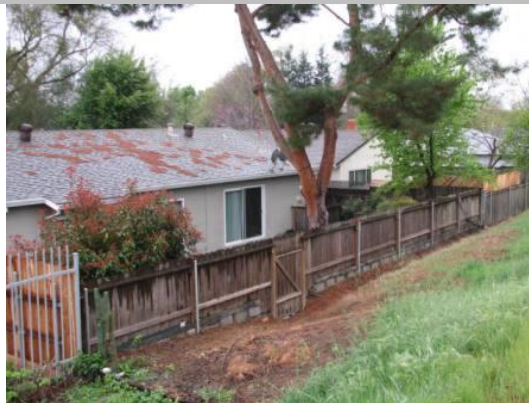
Photo 1 of 1 : SP_2016_NA0001_55_110_20160229_00094.jpg

LM Start	8.51	Rating **	U	Issue No.	110
LM End	8.51	Issue Type +	En	Location *	LS
Category	Earthen Levee			GPS Latitude/Longitude	
				Start	End
Item	Encroachments			38.563732 °	38.563732 °
				-121.388930 °	-121.388930 °
DWR ID	DWR_NA0001_04_s _ 2012_110				
Comment Code					
FE : Fence					
Inspector Comment					
Wood privacy fence within 10-ft of levee toe obstructs access and visibility.

03/16/2012 Wood privacy fence completely obstructs access and visibility.

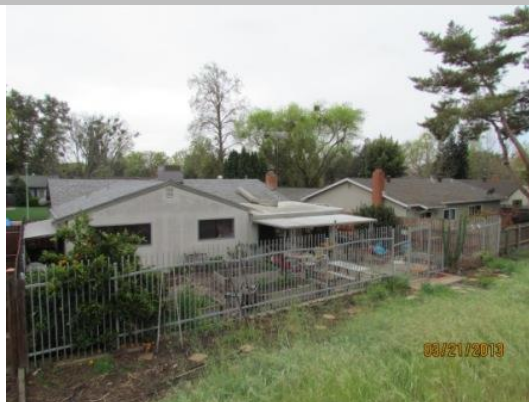
Photo 1 of 1 : SP_2016_NA0001_55_226_20160229_00179.jpg

LM Start	8.52	Rating **	M	Issue No.	226
LM End	8.52	Issue Type +	En	Location *	LS
Category	Earthen Levee			GPS Latitude/Longitude	
				Start	End
Item	Vegetation			38.563793 °	38.563793 °
				-121.388758 °	-121.388758 °
DWR ID	DWR_NA0001_04_s _ 2012_226				
Comment Code					
V6 : Landscaping					
Inspector Comment					
Garden, trees and cactus planted against the levee toe.

View of landscaping at the levee toe.

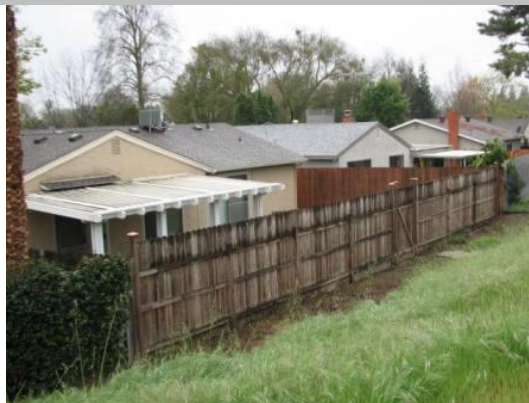
Photo 1 of 1 : SP_2016_NA0001_55_111_20160229_00095.jpg

LM Start	8.53	Rating **	U	Issue No.	111
LM End	8.53	Issue Type +	En	Location *	LS
Category	Earthen Levee			GPS Latitude/Longitude	
				Start	End
Item	Encroachments			38.563820 °	38.563820 °
				-121.388518 °	-121.388518 °
DWR ID	DWR_NA0001_04_s_2012_111				
Comment Code					
FE : Fence					
Inspector Comment					
Wood privacy fence within 10-ft of levee toe obstructs access and visibility.

03/16/2012 Wood privacy fence completely obstructs access and visibility.

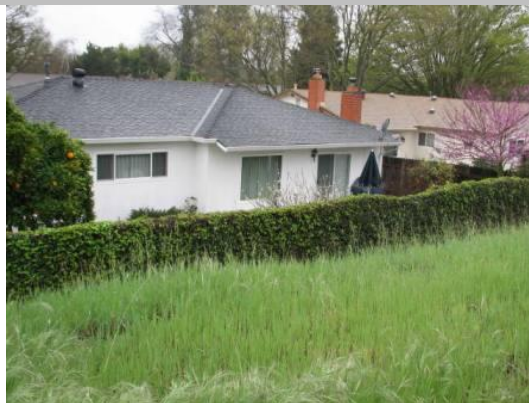
Photo 1 of 1 : SP_2016_NA0001_55_114_20160229_00098.jpg

LM Start	8.57	Rating **	U	Issue No.	114
LM End	8.57	Issue Type +	En	Location *	LS
Category	Earthen Levee			GPS Latitude/Longitude	
				Start	End
Item	Vegetation			38.564020 °	38.564020 °
				-121.387887 °	-121.387887 °
DWR ID	DWR_NA0001_04_s_2012_114				
Comment Code					
V6 : Landscaping					
Inspector Comment					
Ivy and orange tree obstruct visibility.

03/16/2012 Ivy on chainlink fence completely obstructs visibility and access.

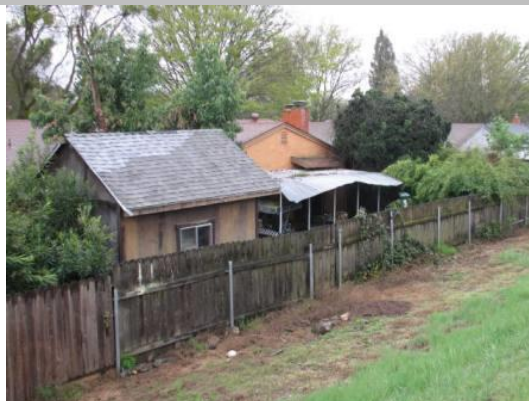
Photo 1 of 1 : SP_2016_NA0001_55_117_20160229_00101.jpg

LM Start	8.59	Rating **	U	Issue No.	117
LM End	8.59	Issue Type +	En	Location *	LS
Category	Earthen Levee			GPS Latitude/Longitude	
				Start	End
Item	Encroachments			38.564094 °	38.564094 °
				-121.387498 °	-121.387498 °
DWR ID	DWR_NA0001_04_s_2012_117				
Comment Code					
FE : Fence					
Inspector Comment					
Wood privacy fence and wood out building within 10-ft of levee toe obstructs access and visibility.

03/16/2012 Wood privacy fence completely obstructs access and visibility.

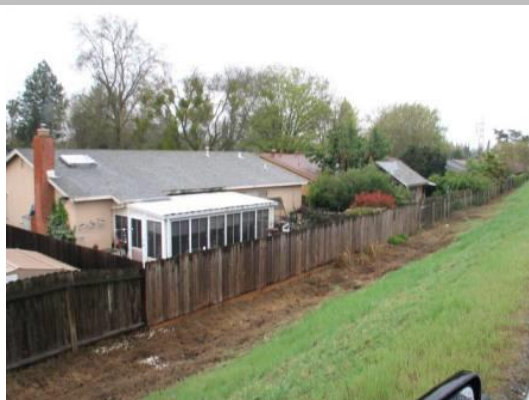
Photo 1 of 1 : SP_2016_NA0001_55_116_20160229_00100.jpg

LM Start	8.60	Rating **	U	Issue No.	116
LM End	8.60	Issue Type +	En	Location *	LS
Category	Earthen Levee			GPS Latitude/Longitude	
				Start	End
Item	Encroachments			38.564133 °	38.564133 °
				-121.387318 °	-121.387318 °
DWR ID	DWR_NA0001_04_s_2012_116				
Comment Code					
FE : Fence					
Inspector Comment					
Wood privacy fence within 10-ft of levee toe obstructs access and visibility.

03/16/2012 Wood privacy fence completely obstructs access and visibility.

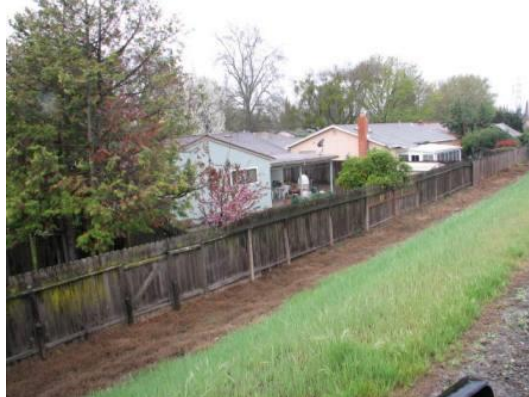
Photo 1 of 1 : SP_2016_NA0001_55_118_20160229_00102.jpg

LM Start	8.61	Rating **	U	Issue No.	118
LM End	8.61	Issue Type +	En	Location *	LS
Category	Earthen Levee			GPS Latitude/Longitude	
				Start	End
Item	Encroachments			38.564133 °	38.564133 °
				-121.387092 °	-121.387092 °
DWR ID	DWR_NA0001_04_s _ 2012_118				
Comment Code					
FE : Fence					
Inspector Comment					
Wood privacy fence within 10-ft of levee toe obstructs access and visibility.

03/16/2012 Wood privacy fence completely obstructs access and visibility.

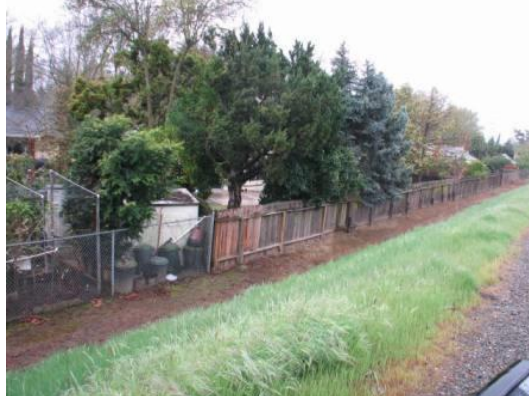
Photo 1 of 1 : SP_2016_NA0001_55_119_20160229_00103.jpg

LM Start	8.63	Rating **	U	Issue No.	119
LM End	8.63	Issue Type +	En	Location *	LS
Category	Earthen Levee			GPS Latitude/Longitude	
				Start	End
Item	Encroachments			38.564217 °	38.564217 °
				-121.386846 °	-121.386846 °
DWR ID	DWR_NA0001_04_s _ 2012_119				
Comment Code					
FE : Fence					
Inspector Comment					
Wood privacy fence within 10-ft of levee toe obstructs access and visibility.

03/16/2012 Wood privacy fence completely obstructs access and visibility.

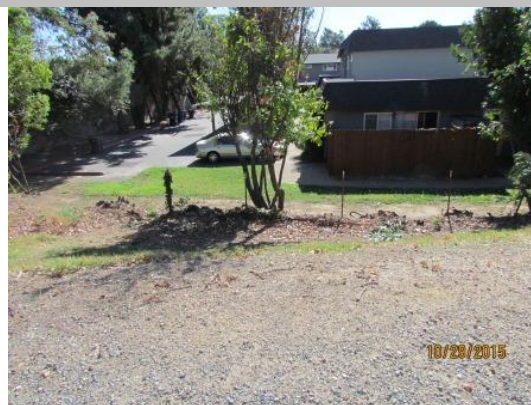
Photo 1 of 1 : SP_2016_NA0001_55_230_20160229_00180.jpg

LM Start	8.83	Rating **	N	Issue No.	230
LM End	8.83	Issue Type +	Ma	Location *	LS
Category	Earthen Levee			GPS Latitude/Longitude	
				Start	End
Item	Trim / Thin Trees			38.564929 °	38.564929 °
				-121.383248 °	-121.383248 °
DWR ID	DWR_NA0001_04_f_2015_230				
Comment Code					
T5 : Tree stumps.					
Inspector Comment					
5 shrub stumps with multiple branches.

View of the multiple tree stumps at the landside levee toe.

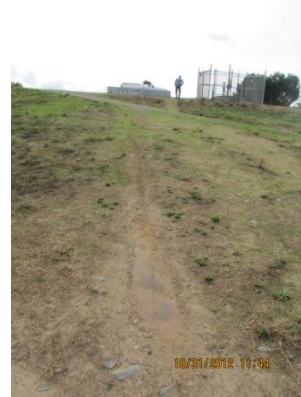
Photo 1 of 2 : SP_2016_NA0001_55_175_20160229_00151.jpg

LM Start	9.41	Rating **	A/W	Issue No.	175
LM End	9.41	Issue Type +	En	Location *	WS
Category	Earthen Levee			GPS Latitude/Longitude	
				Start	End
Item	Encroachments			38.566700 °	38.566700 °
				-121.372961 °	-121.372961 °
DWR ID	DWR_NA0001_04_s_2012_175				
Comment Code					
PI : Pipe					
Inspector Comment					
Flap gates in good condition. Pipe is exposed at waterside toe.

View of exposed pipe at waterside toe.

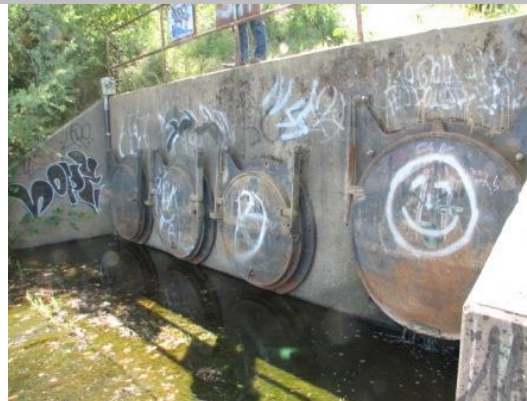
Photo 2 of 2 : SP_2016_NA0001_55_175_20160229_00152.jpg

LM Start	9.41	Rating **	A/W	Issue No.	175 (cont)
LM End	9.41	Issue Type +	En	Location *	WS

Drainage outfall to American River.

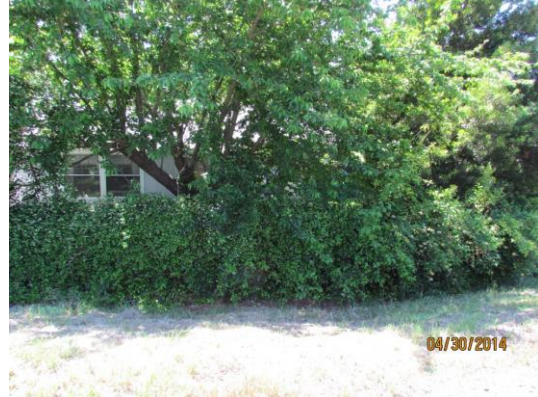
Photo 1 of 1 : SP_2016_NA0001_55_236_20160229_00183.jpg

LM Start	9.48	Rating **	M	Issue No.	236
LM End	9.48	Issue Type +	En	Location *	LS
Category	Earthen Levee			GPS Latitude/Longitude	
				Start	End
Item	Vegetation			38.566948 °	38.566948 °
				-121.371562 °	-121.371562 °
DWR ID	DWR_NA0001_04_s _ 2012_236				
Comment Code					
V6 : Landscaping					
Inspector Comment					
Landscaping within 10-ft of levee toe.

View of the landscaping at the landside levee to obstructing visibility and access.

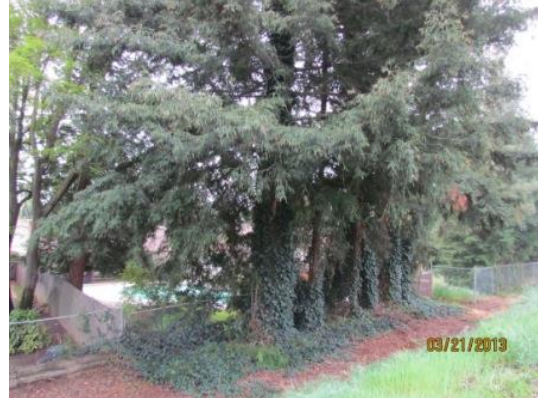
Photo 1 of 1 : SP_2016_NA0001_55_237_20160229_00184.jpg

LM Start	9.48	Rating **	M	Issue No.	237
LM End	9.48	Issue Type +	En	Location *	LS
Category	Earthen Levee			GPS Latitude/Longitude	
				Start	End
Item	Vegetation			38.566938 °	38.566938 °
				-121.371550 °	-121.371550 °
DWR ID	DWR_NA0001_04_s _ 2012_237				
Comment Code					
V6 : Landscaping					
Inspector Comment					
Redwoods and ivy along fence within 10-ft of levee toe.

View of landscaping at levee toe.
